Case Study – Alumina Storage Silo, SIMEC Power SUF

Alumina Storage Silo

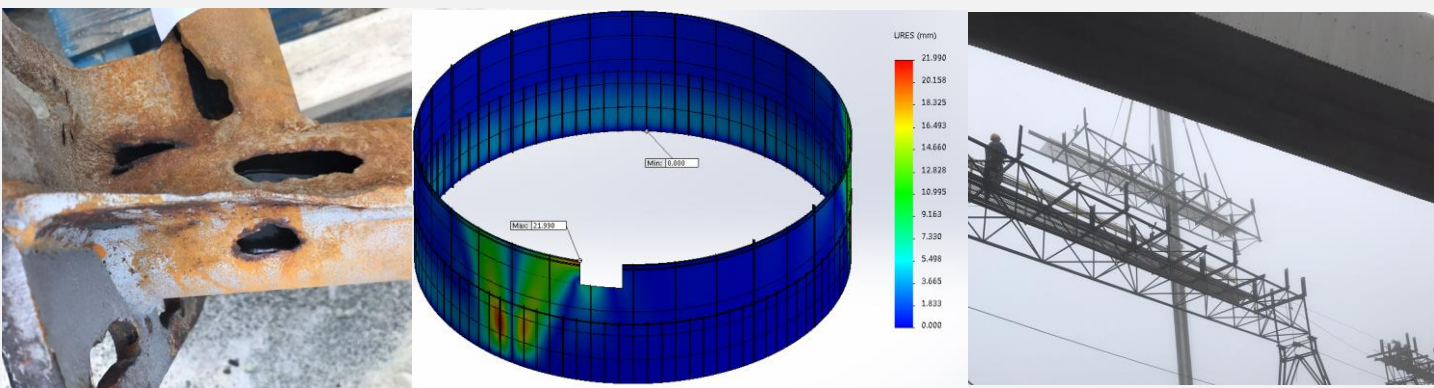
Internal and external visual inspection, NDT on welds, UTT, dimensional control and ground investigation carried out to assess buckling failure on alumina storage silo structure.

FEA carried out as per original design. Local analysis for evaluating repair method. Deconstruction of overhead structures and unloading of silo to mitigate further structural damage.
